UNDERWATER BRIDGE INSPECTION REPORT

STRUCTURE NO. 66515

CANNON RIVER

DISTRICT 6 - RICE COUNTY

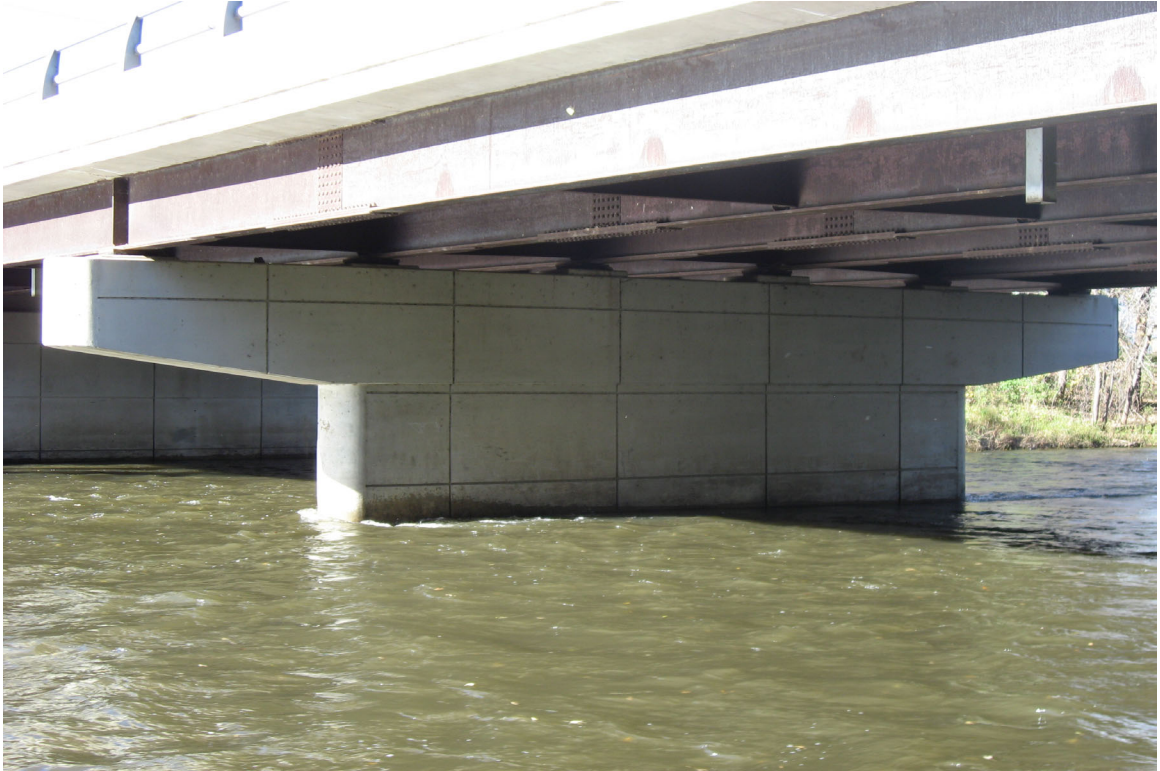
Photograph 1. View of Pier 1, Looking Northeast.

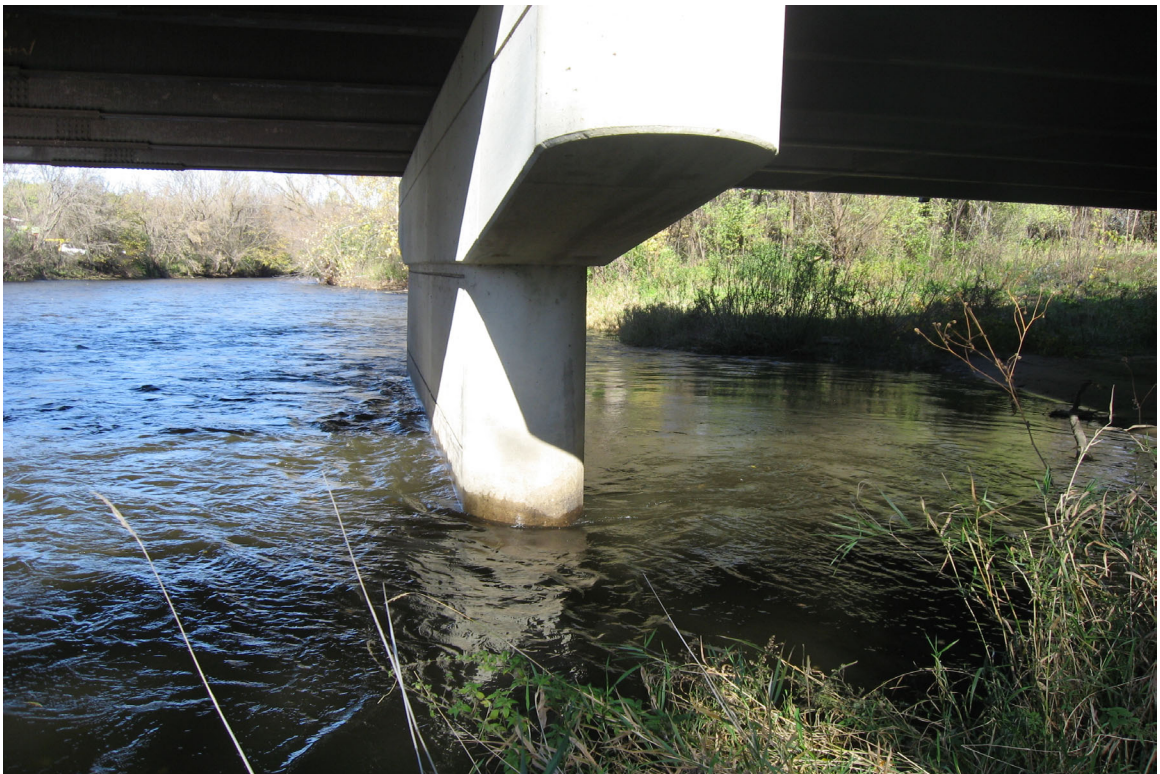
Photograph 2. View of Pier 2, Looking North.

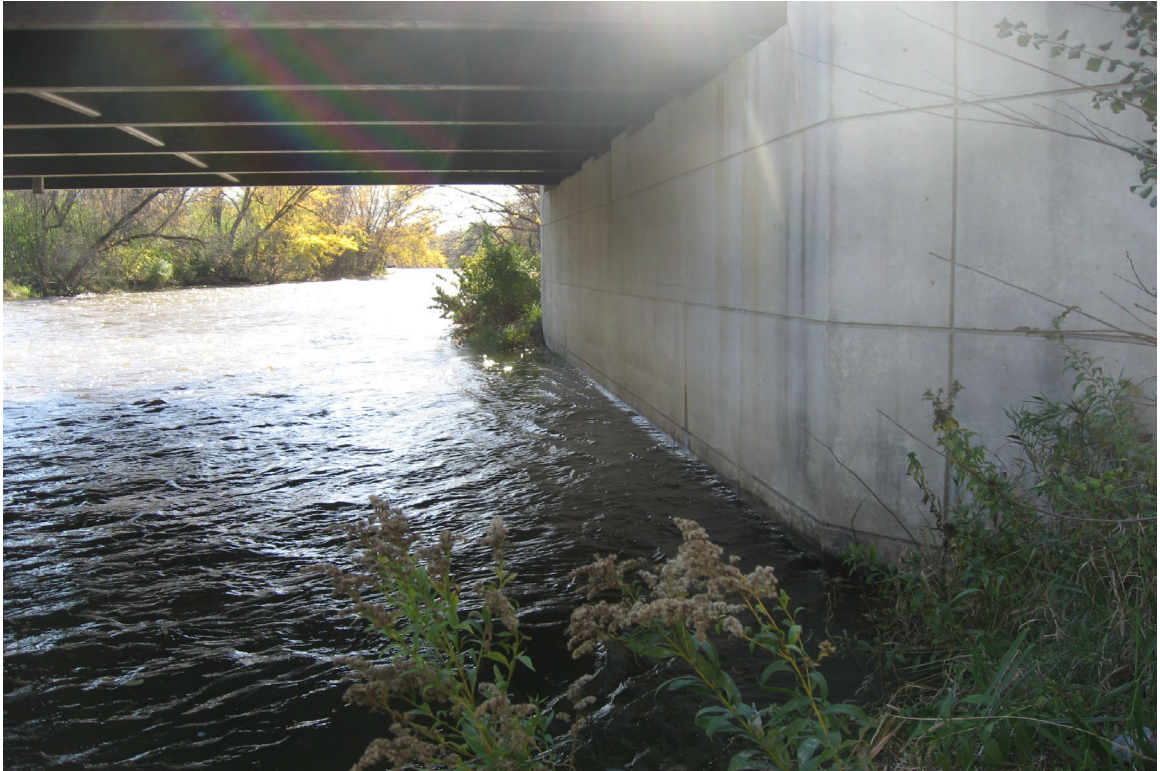
Photograph 3. View of West Abutment, Looking Southwest.
